Oil Leakage –
Rear Output Flange Of Transfer Case –
Repair Procedure

MODEL 2002 MY
X-TYPE
VIN C00294-D01489

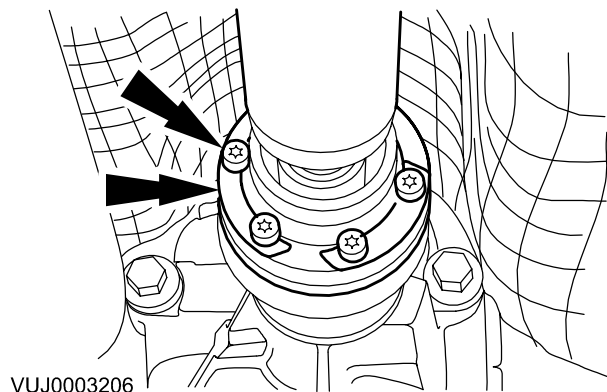
ILLUSTRATION 1

OUTPUT FLANGE BOLTS AND LOCKING LINKS

3. Remove and discard driveshaft front CV joint to transfer case rear output flange securing bolts and locking links (Illustration 1).

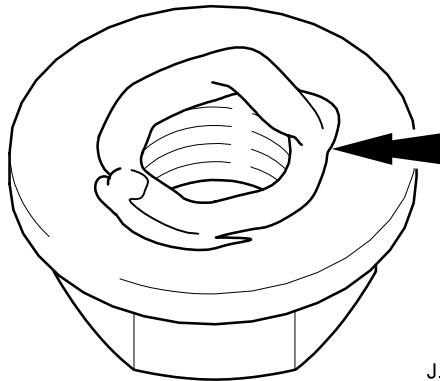
ILLUSTRATION 3

SEALER APPLIED TO MATING FACE OF NUT

11. Apply sealer (C2S 12099) to mating face of transfer case rear output flange securing nut (Illustration 3).
12. Install the securing nut on the transfer case rear output flange and tighten to 160 Nm.
13. Remove special tool 205-053 from the transfer case rear output flange.
14. Remove and discard grease from driveshaft front CV joint.
15. Repack driveshaft front CV joint with two sachets of grease.
16. Install new gasket and align driveshaft front CV joint to transfer case rear output flange.

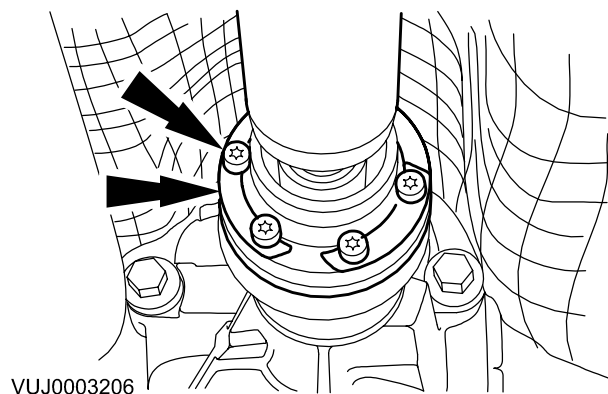
ILLUSTRATION 4

INSTALLATION OF NEW BOLTS AND LOCKING LINKS

17. Install new locking links and driveshaft front CV joint to transfer case rear output flange securing bolts and tighten to 44 Nm (Illustration 4).
18. Lower twin post lift.
